DayCor® II

The Most Advanced Daytime Corona Imager

**The Indispensable
Predictive
Maintenance
Tool to Enhance
Electrical Utility
Reliability**

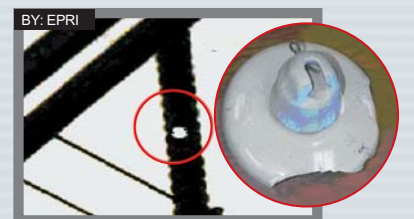
Broken porcelain bell.
